THESIS

A PRELIMINARY INVESTIGATION OF THE
CORROSION AND STRESS-CORROSION SUSCEPTIBILITY
OF THERMOMECHANICALLY PROCESSED HIGH MAGNESIUM
ALUMINUM MAGNESIUM ALLOYS

Larry Edward Beberdick

September 1981

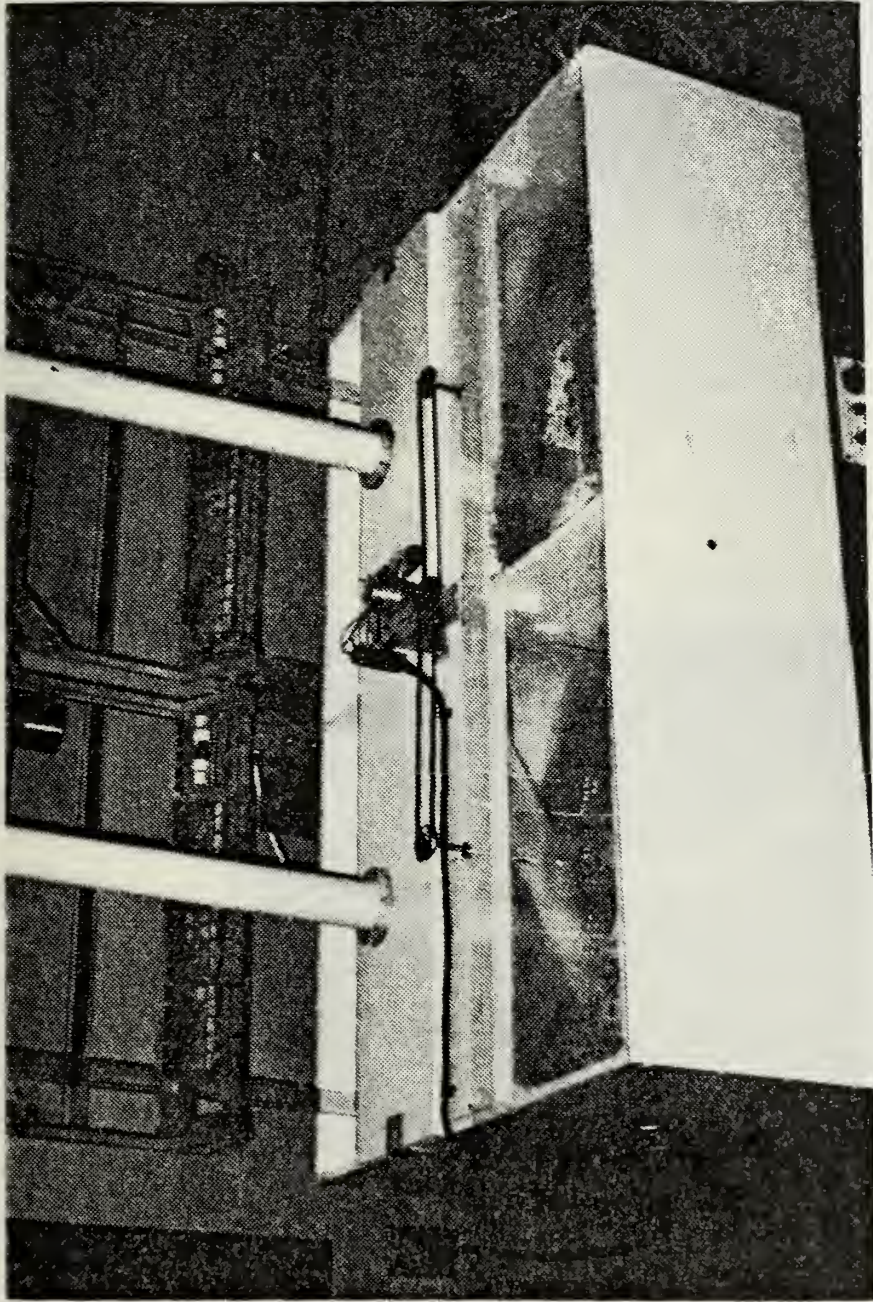
Figure 3. General and stress corrosion test tank. In the foreground are the two general corrosion spray chambers. In the background are two stress corrosion alternate immersion racks, and in the center are the exhaust ducts.

Stress corrosion testing was accomplished by alternate immersion in a 3.5% NaCl solution. The test cycle was 10 minutes immersed followed by 50 minutes air drying [Refs. 10,11 and 12]. The test chamber, shown in Figure 3, was constructed of Marine-grade plywood and painted with a water-sealing paint. Tank dimensions were 30 inches x 12.5 inches x 50 inches (762 mm x 317 mm x 1270 mm). The salt water in the tank was maintained at a depth of 3.5 - 4.0 inches (89-102 mm), i.e. approximately 20-24 gallons (76-91 l) of liquid.

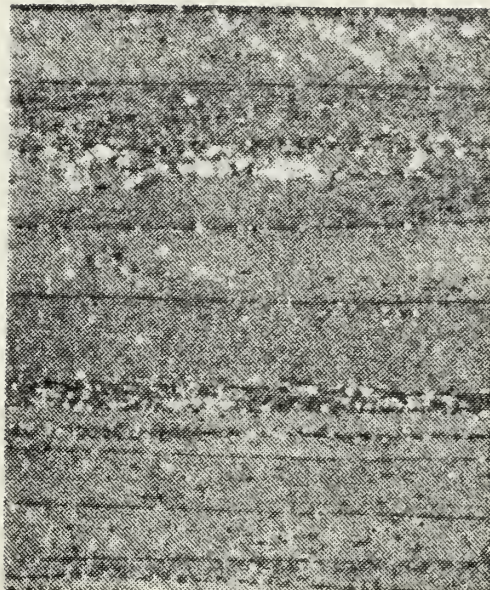
Figure 14. The as rolled material: a) 8% Mg, b) 10% Mg, c) 10% Mg, 0.4% Cu, d) 10% Mg, 0.4% Cu, 0.5% Mn. Etched at 20 volts for 20 seconds in Barkers reagent. 500X.

The microstructures and mechanical properties of the warm-rolled alloys processed for this investigation are similar to those reported by Johnson [Ref. 1] in his study of this thermo-mechanical processing method. Figure 14 shows micrographs of longitudinal sections for the four warm-rolled alloys investigated. The 8% Mg and 10% Mg alloys both exhibit highly elongated grains with some precipitation of the beta (β) phase in grain boundaries. Fewer and smaller β particles are present in the 8% Mg alloy (Fig. 14a) when compared to the 10% Mg alloy (Fig. 14b). The 8% Mg alloy exhibits generally less precipitation within grains whereas the 10% Mg alloy appears to have precipitation within grains and concentrated along slip bands. Cadwell [Ref. 2], in his study of the fatigue characteristics, also examined this 10% Mg alloy by transmission electron microscopy. While still tentative, the results obtained are consistent with the results of this investigation, i.e. that precipitation occurs on slip bands in the 10% Mg alloy. Cadwell [Ref. 2] also observed a fine (0.3 - 0.5 μm) dislocation cell structure in regions distant from the precipitated β particles.

The addition of 0.4% Cu to a 10% Mg alloy results in a more homogenous microstructure after warm rolling (Fig. 14c).

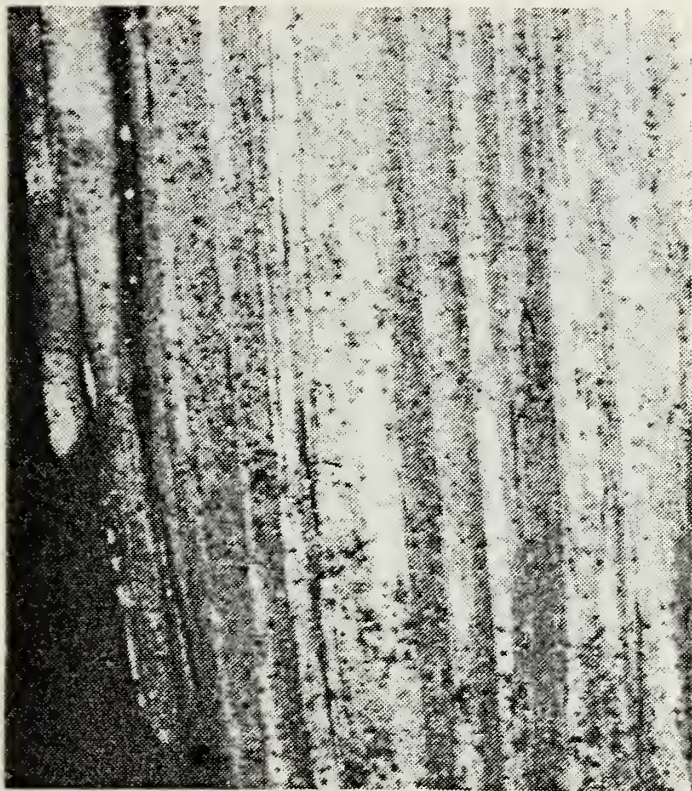
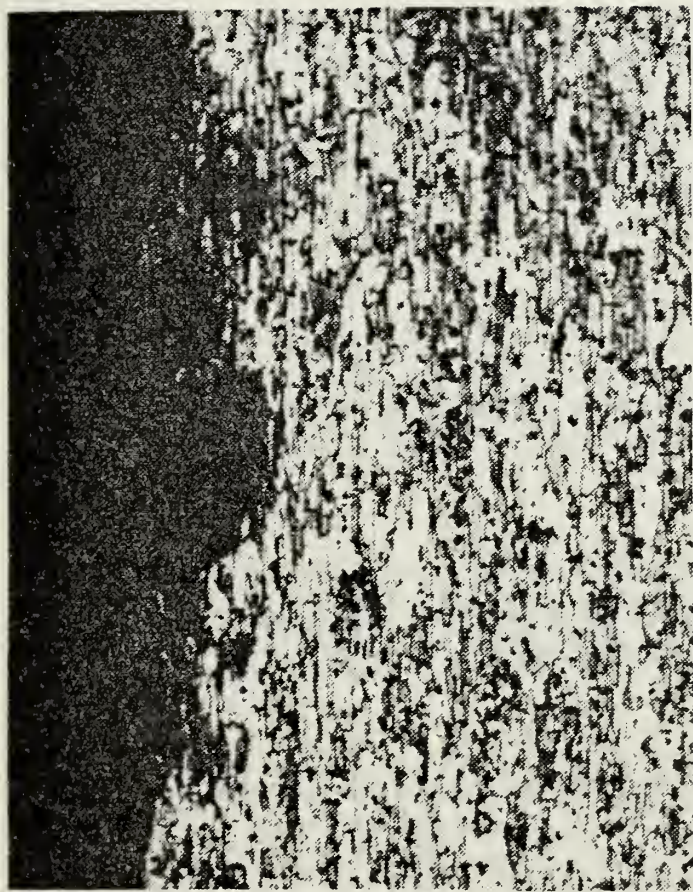
Figure 18. The as rolled/as received material after 740 hours of alternate immersion stress corrosion exposure: a) 8% Mg, b) 10% Mg, c) 10% Mg, 0.4% Cu, d) 10% Mg, 0.4% Cu, 0.5% Mn, e) 7075-T6. The Al-Mg alloys were etched for 20 seconds at 20 volts in Barkers reagent, the 7075-T6 was etched in Kellers etch for 20 seconds.

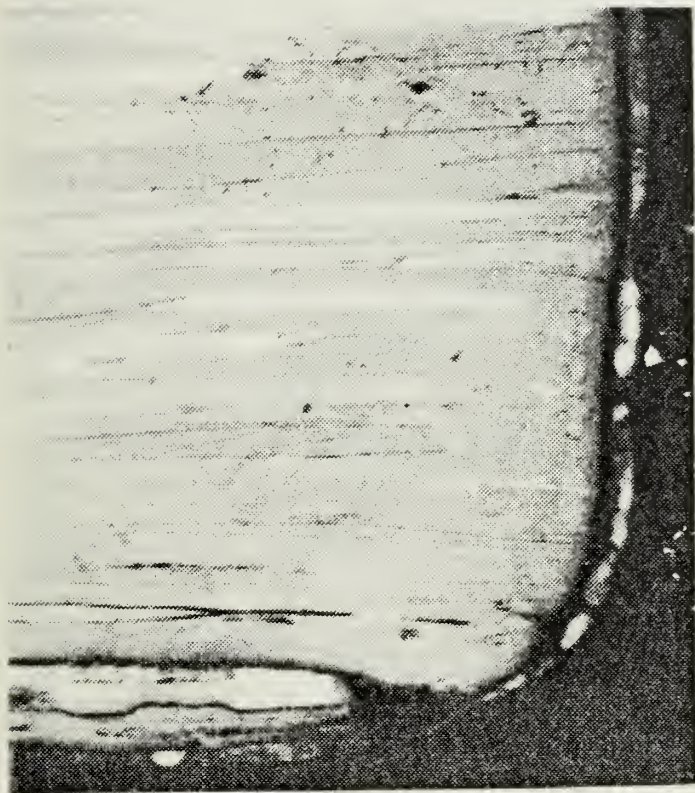
Figure 34. The ends of the general corrosion samples after 1000 hours of salt spray exposure: a) 8% Mg, b) 10% Mg, c) 10% Cu, d) 10% Mg 0.4% Cu, 0.5% Mn, e) 7075-T6. The Al-Mg alloys were etched at 20 volts for 20 seconds in Barkers reagent, 7075-T6 was etched in Kellers etch for 20 seconds. 500X.
